**SERVICE BULLETIN No.11 / 2018****Information on the correct installation of the Bowden/activation cable**

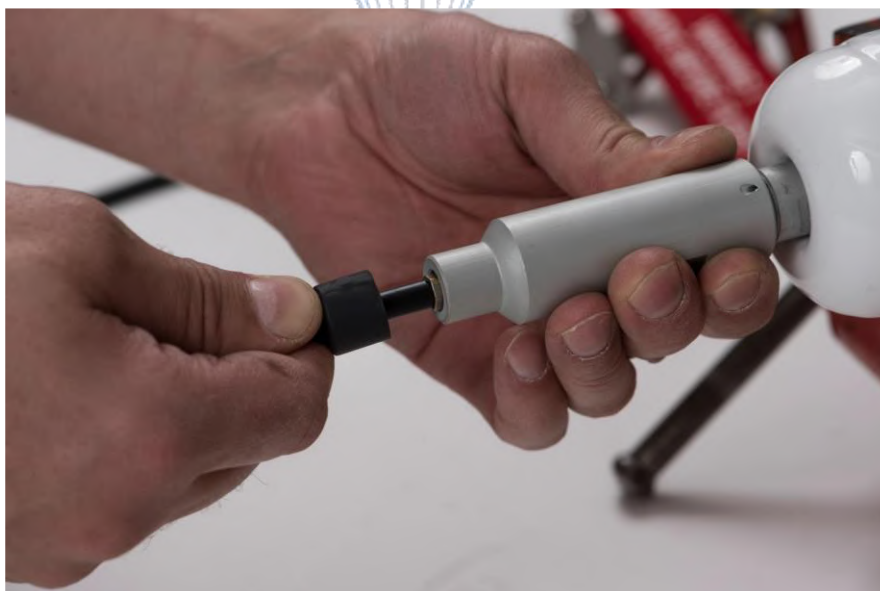
Persons concerned, who have performed the assembly of the activation kit of the Magnum rescue system with the rocket engine, shall make a visual inspection of the joint concerned on all Magnum rescue systems assembled by them.  
The inspection shall be done by pulling out the dispersive tube from the trigger body (see the following picture)

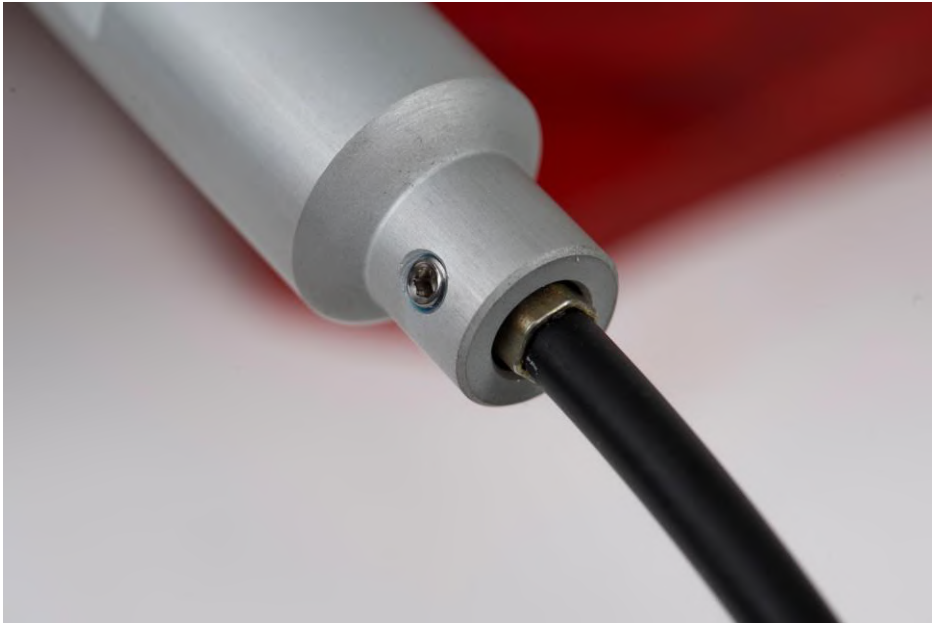
After pulling out the dispersive tube, we should see this: (picture)

In this case, the joint is all right and the dispersive tube will be put back to the original position.

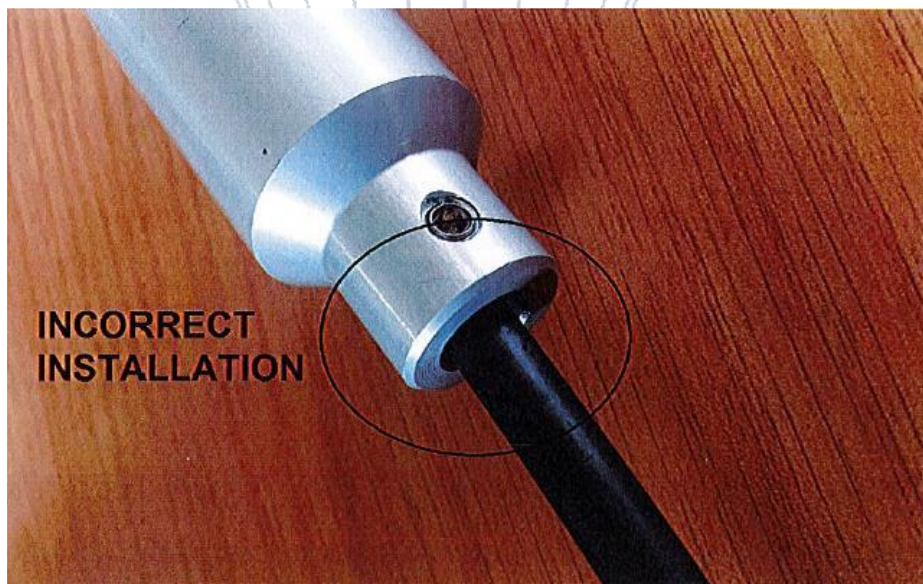
In the event that we see this (picture):

the kit is out of order and it is necessary to loosen the M5 set screw on the trigger body and further proceed according to the Manual 02-RT page 92-102.
